Northwest Branch

Watershed Study

Montgomery County

March 17, 1997

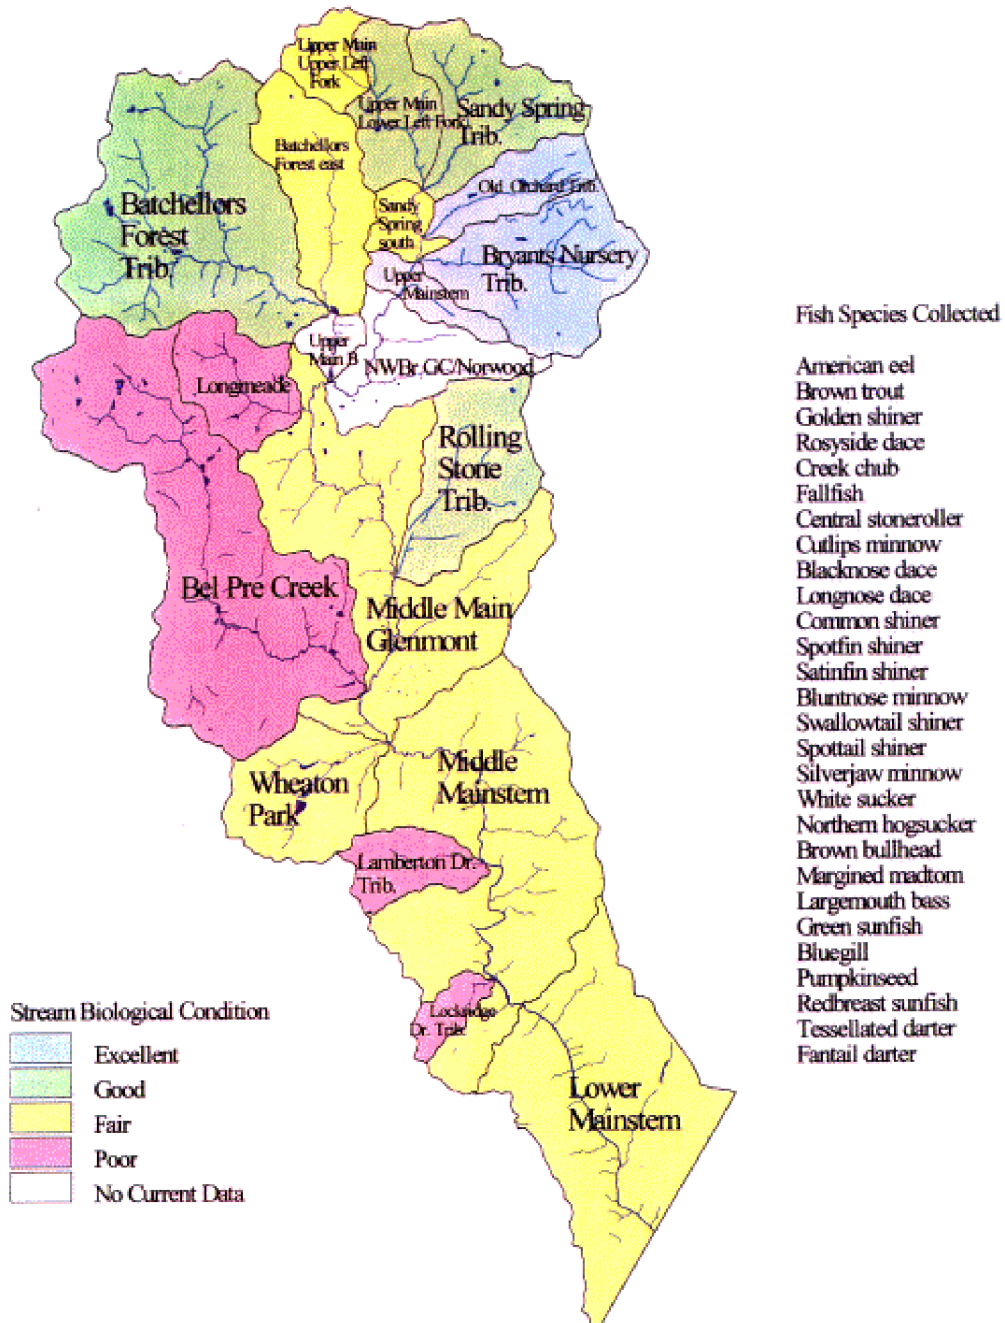
Figure 3. Stream Conditions Within the Northwest Branch Watershed

Currently, the Bryant's Nursery Tributary and Old Orchard Tributary subwatersheds contain *excellent* resource conditions. Bryant's Nursery was remonitored in 1996 to verify its condition as a result of a massive sediment violation. The Batchellors Forest, Sandy Spring west tributary, and Rolling Stone Tributary subwatersheds contain *good* resource conditions. The Bel Pre Creek, Lamberton Tributary, and Lockridge Drive Tributary currently contain *poor* resource conditions. The rest of the Northwest Branch watershed is currently rated as having a *fair* resource condition (Figure 3).

The Bel Pre subwatershed has a *poor* overall resource condition (Figure 3). All 3 of the monitoring stations located on the Bel Pre Creek (NWBP201, NWBP203, and NWBP205) were rated with a *poor* benthic macroinvertebrate IBI class, but having good habitat (Figure 4). If habitat is not a limiting factor, then the impairment could be caused by uncontrolled flows or a water quality problem. The same trends are evident in examining the relationship between IBI scores and habitat values for the fish monitoring results (Figure 4).

In addition, DEP proposes to further investigate the Bel Pre Tributary through the Pipe Detectives program to detect and correct any illicit discharges in the drainage.

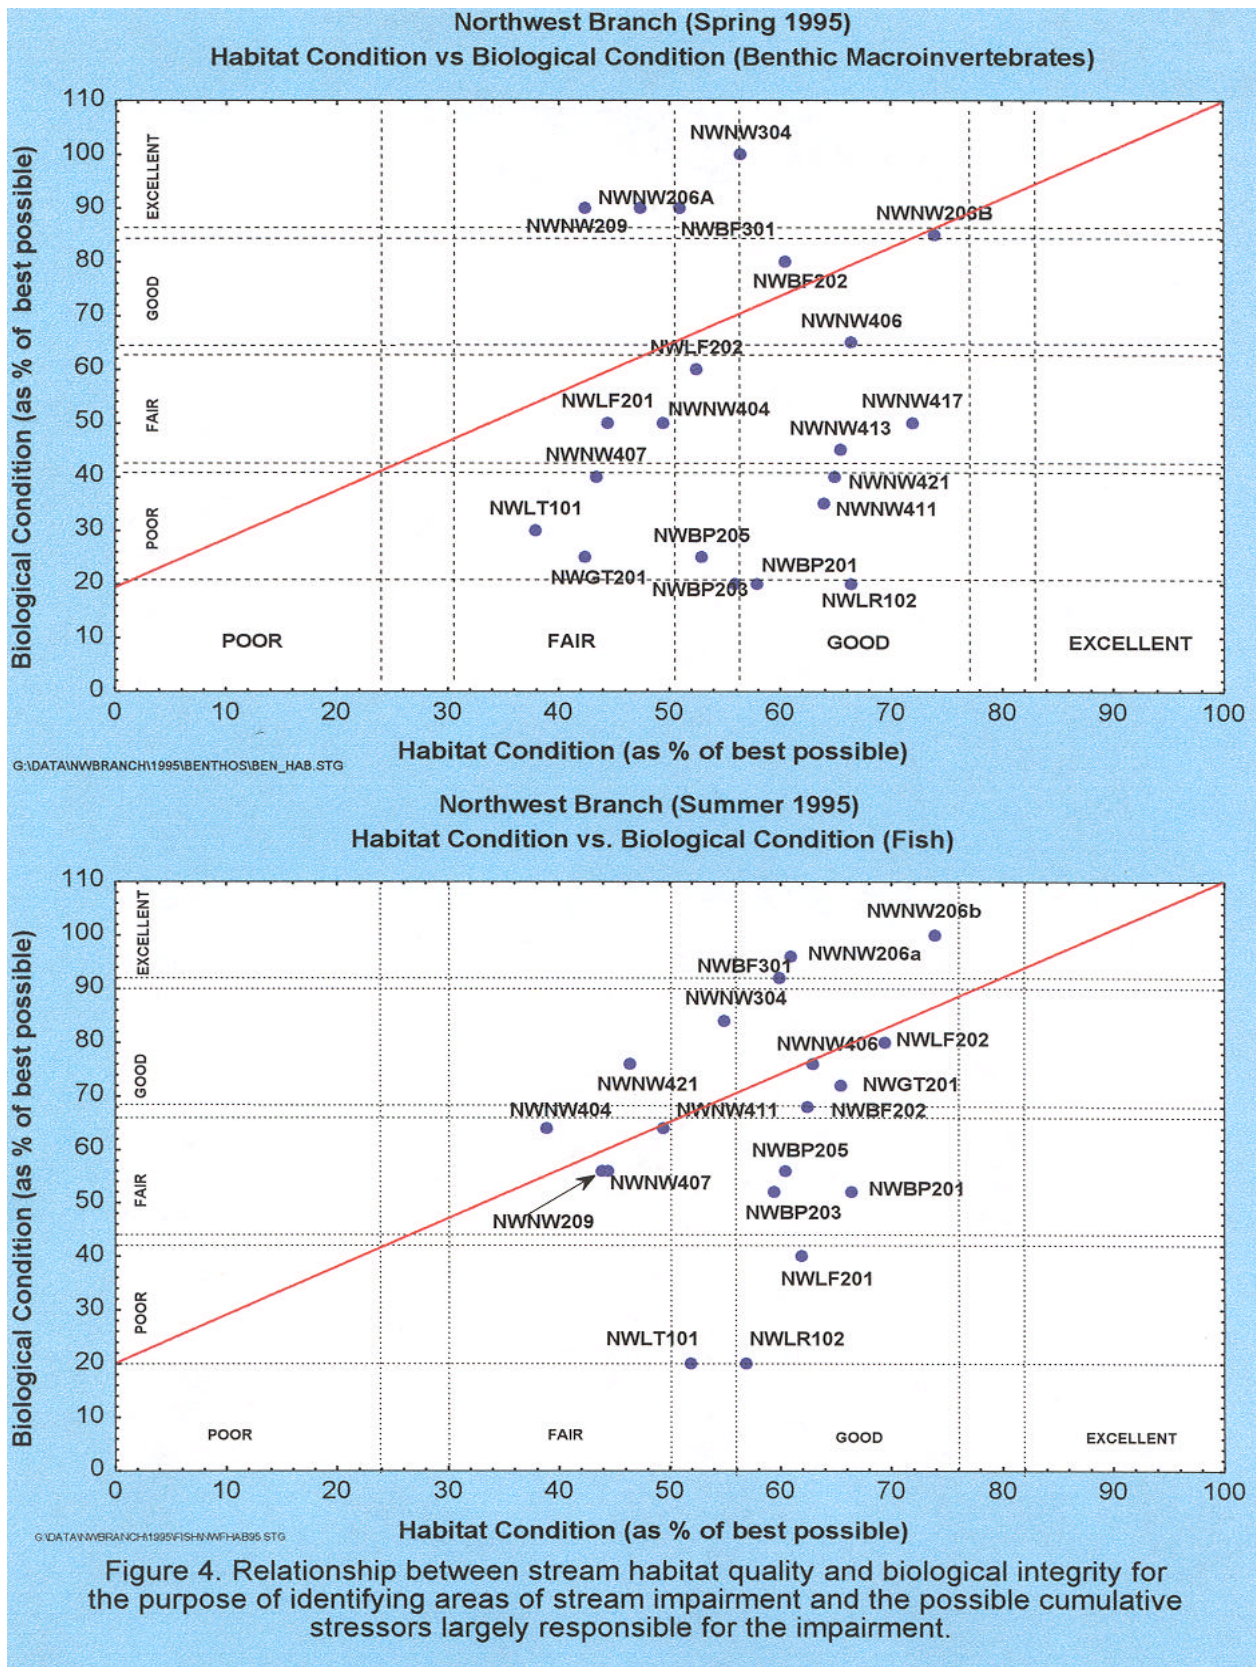
Relatively few stream areas had unimpaired conditions in both benthic macroinvertebrate and fish IBI scores (Figure 4). The benthic macroinvertebrate results had more stations with IBI/habitat scores along the expected IBI/habitat curve shown in red in Figure 4. As habitat changes, so should the IBI score change, all other factors being equal. The benthic macroinvertebrates habitat parameters could be related to specific riffle habitat features such as dominant particle size.

The monitoring station (NWNW209) received an *excellent* spring benthic macroinvertebrate IBI class score and a fair habitat score (Figure 4). There could be a spring nutrient enrichment occurring in this tributary from the upstream residential developments. The same area received only a *fair* fish IBI class score and a fair stream habitat assessment indicating that some level of habitat impairment is occurring in this tributary and that the fish community is responding to the habitat conditions.

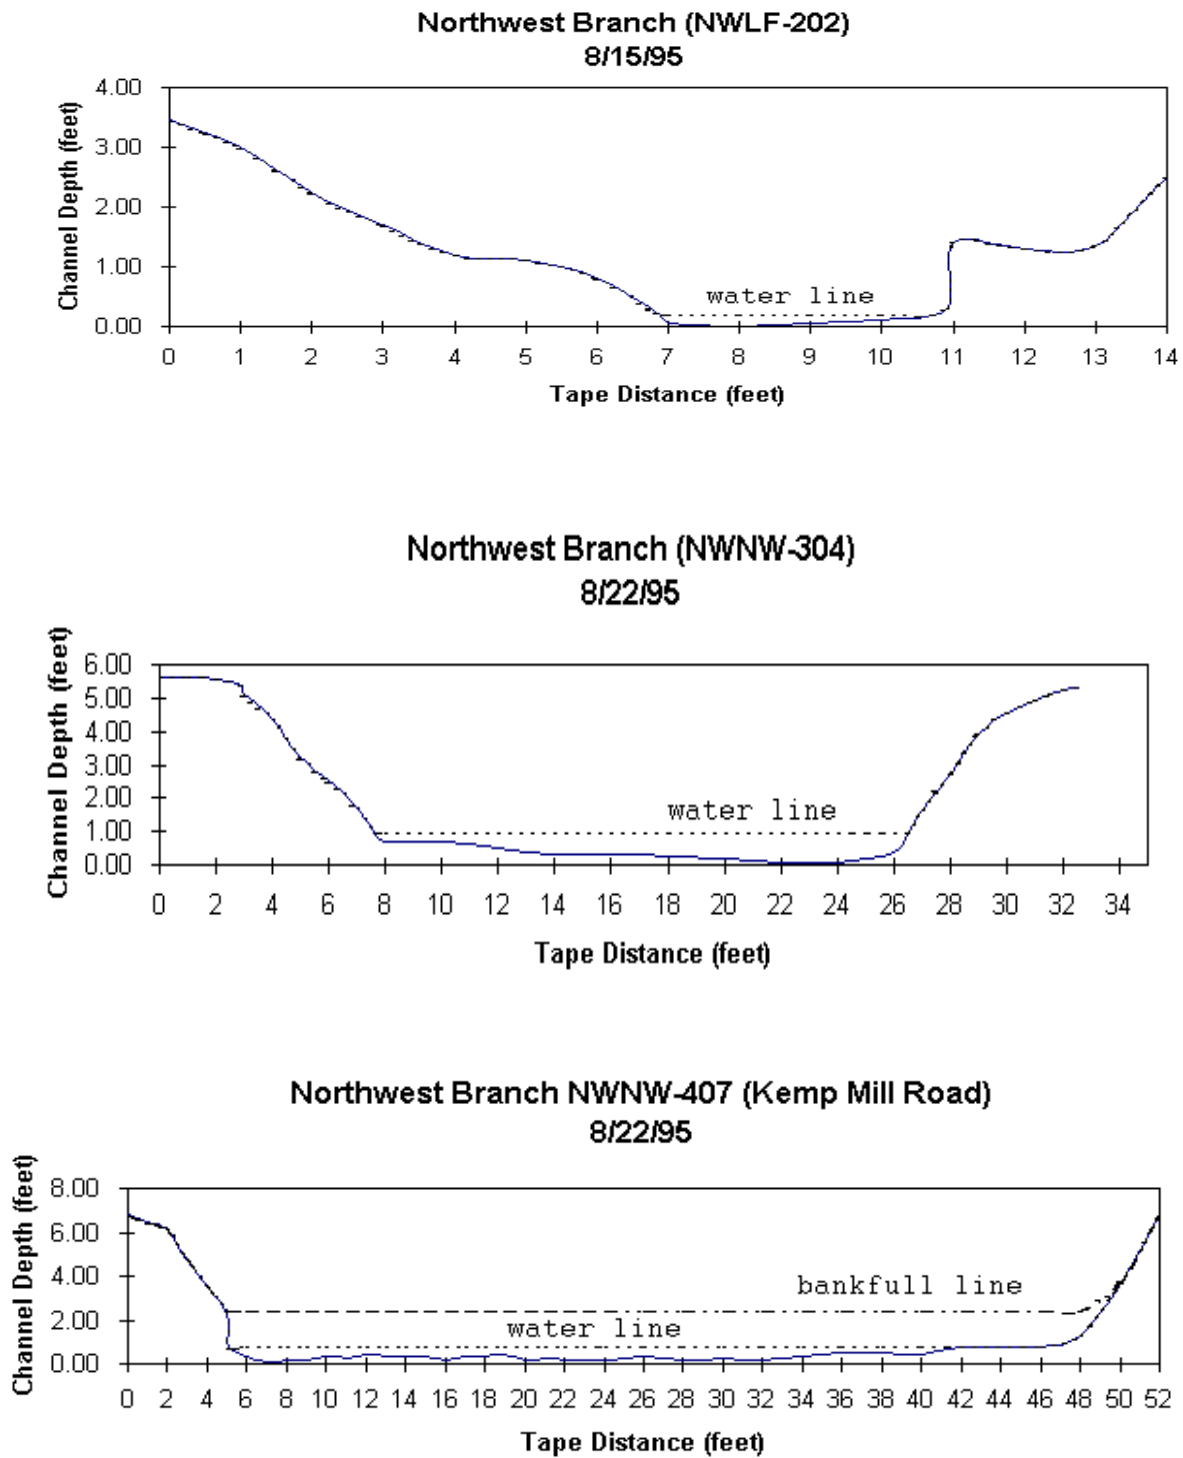
Figure 5. Cross sectional measurements in upper, middle, and lower stations.

Cross sections were established at most of the stations monitored in 1995. Cross sections establish a base line to assess future channel change as well as to understand the present channel condition. The cross sections depict a pattern of increased entrenchment and lateral widening from the top of the watershed to the bottom (Figure 5). The degree of entrenchment is of concern because of the amount of fines currently in the stream system and the problems associated with transporting this fine material. The stream appears so entrenched that it has lost access to its active floodplain. Increased lateral widening is also evident by examining the rows of trees originally growing along the stream banks but now four to five feet inside the channel in the vicinity of the Northwest Golf Course.

The stream still has access to an existing active floodplain in the Bryants Nursery Tributary stations (NWNW-206a & b) (Figure 5). However, after station NWNW-304 (still in the upper 1/3 of the watershed) almost every Northwest Branch station shows a stream that has become highly entrenched with associated lateral widening (Figure 5).

- o to provide for stream restoration in the upper watershed to maintain current *excellent to good* stream conditions, and
- o to provide for stream stabilization and retrofit opportunities in the lower watershed to provide flow control and to stabilize eroding stream banks.

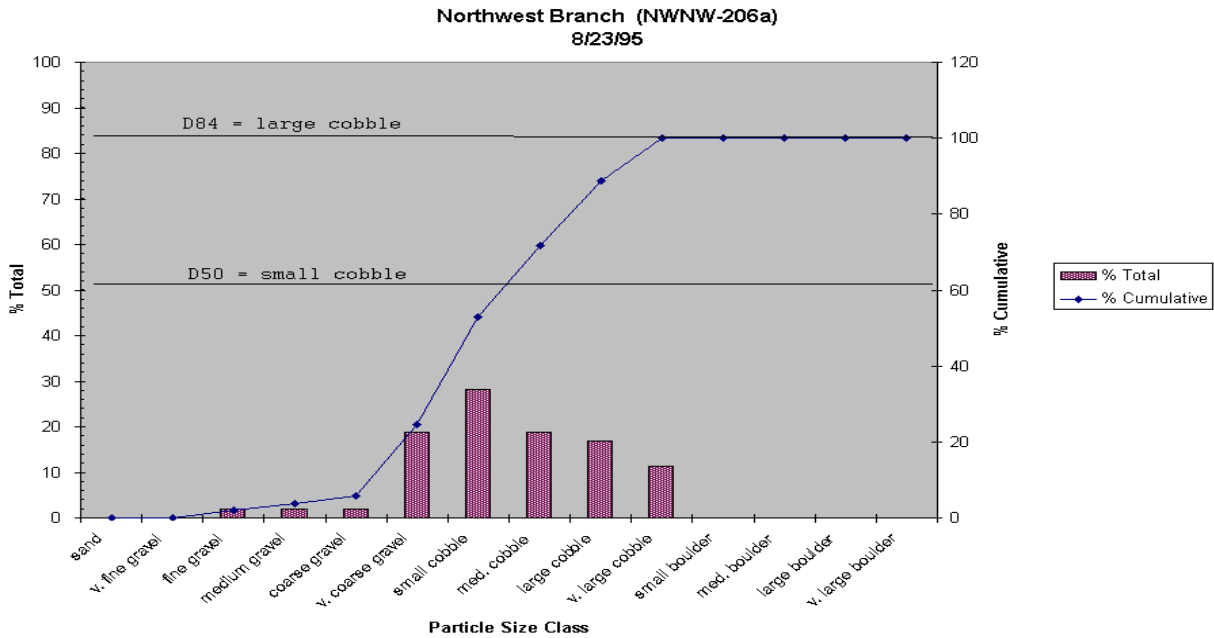
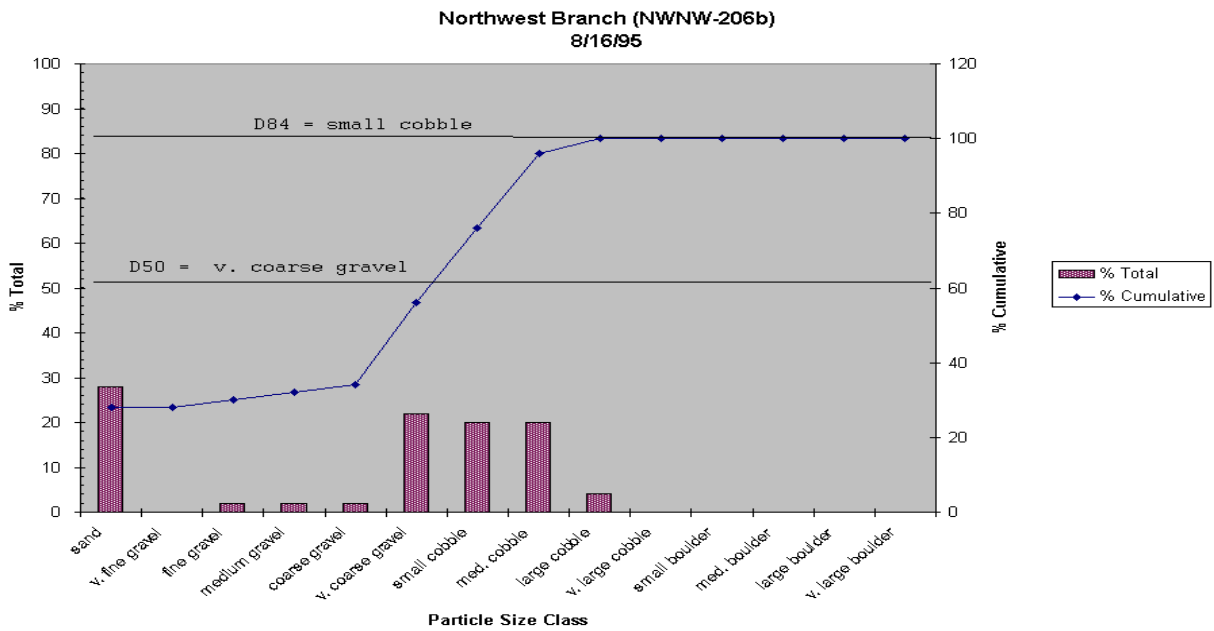
Figure 6. Analysis of Pebble Counts in the Bryants Nursery Tributary. D50 = small cobble to very coarse gravel.

The Bryants Nursery Tributary stations (NWNW206 a & b) D50 was equivalent to small cobble to very coarse gravel (Figure 6). This subwatershed had an excellent resource condition in 1995 and in 1996 when the stations were again monitored as a result of assessing the impacts of a sediment violation. Almost every other station monitored in 1995 had a riffle D50 measurement equivalent to medium to coarse gravel (<32 mm) (Figure 6). The Rolling Stone Tributary had a riffle D50 of fine gravel (4 to 8 mm) (Figure 6). The predominance of small particles in the riffles can become a limiting factor to the ability of the benthic macroinvertebrate community in maintaining a diverse and high quality level of community composition.

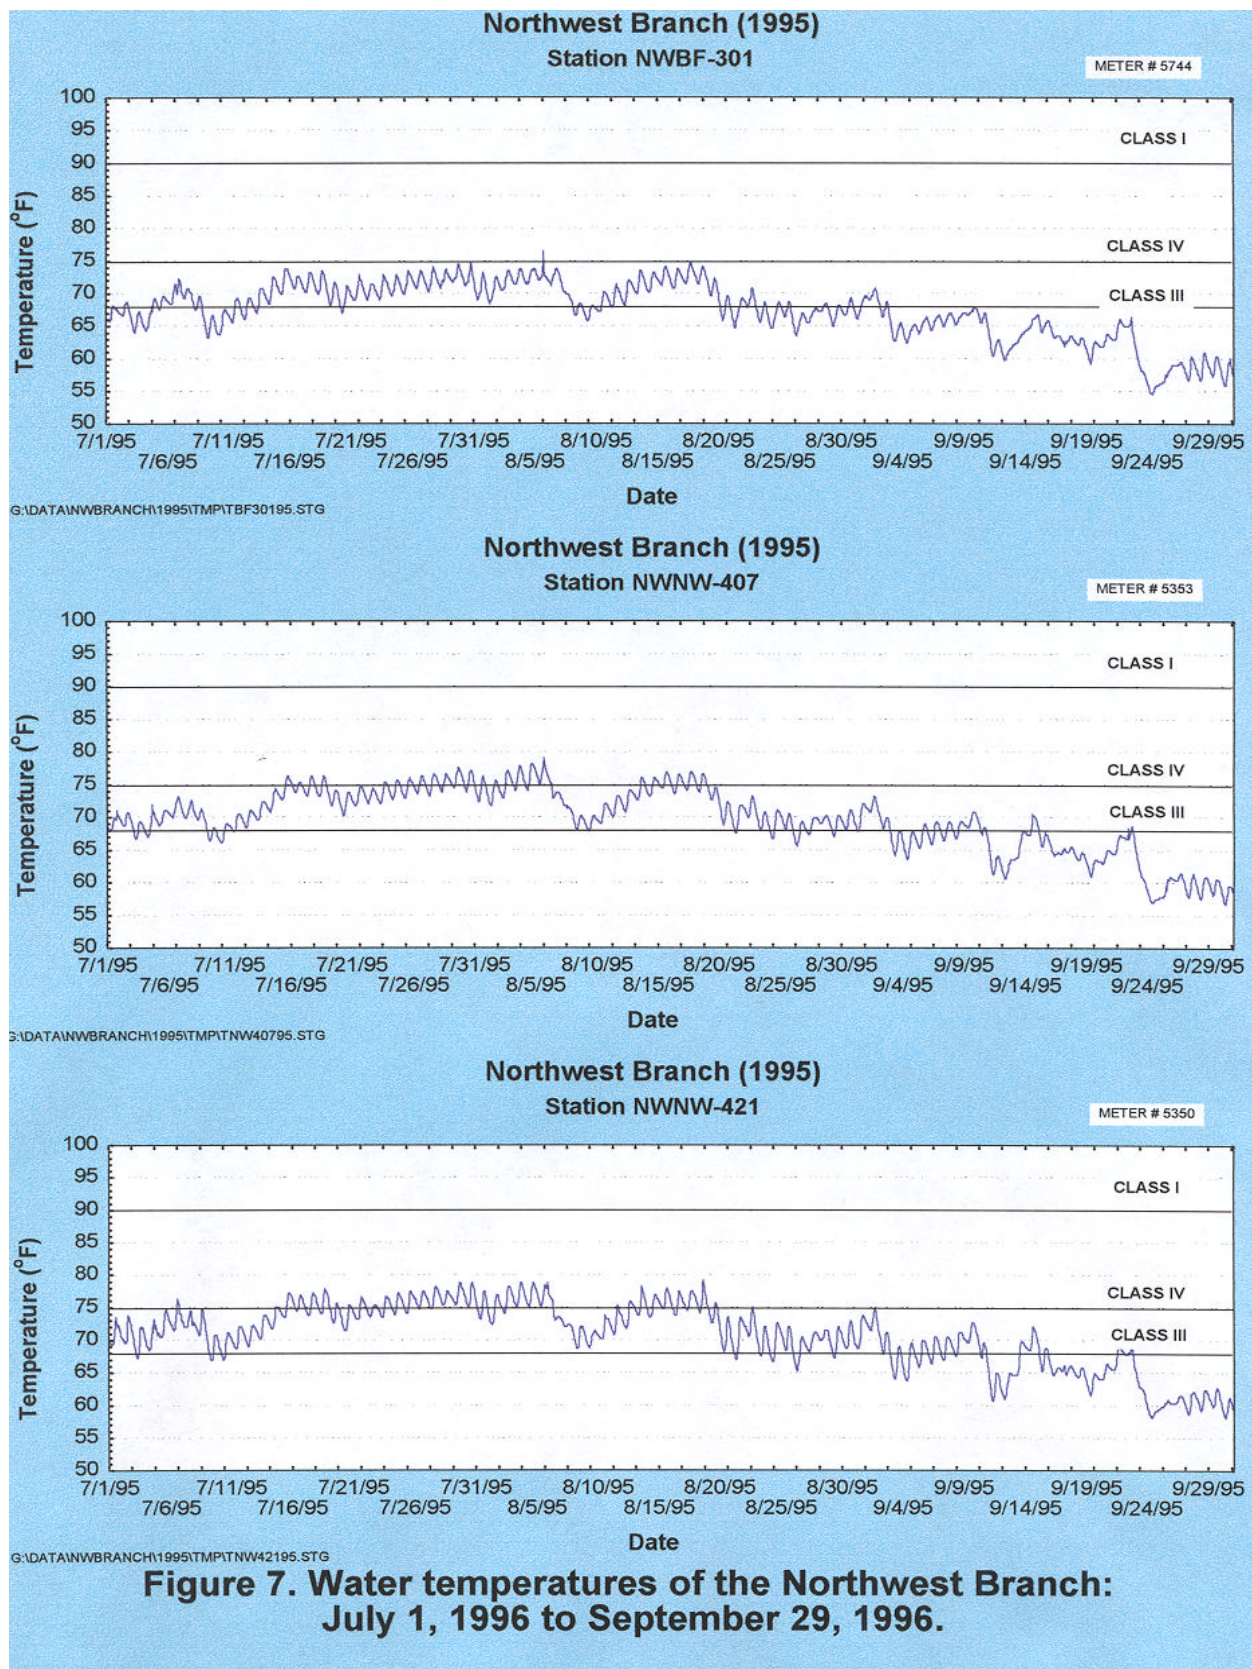
Graphs of water temperatures (recorded hourly) measured throughout the Northwest Branch depict a cool to warmwater resource (Figure 7). Diurnal temperatures during July and August, 1995 range around 22 to 24 degrees Fahrenheit.
